TS-PIC-9904473S/20004473S
December 1999

AERIAL PHOTOGRAPHIC ANALYSIS BROWN'S DUMP STUDY AREA Jacksonville, Florida

Jacksonville, Florida

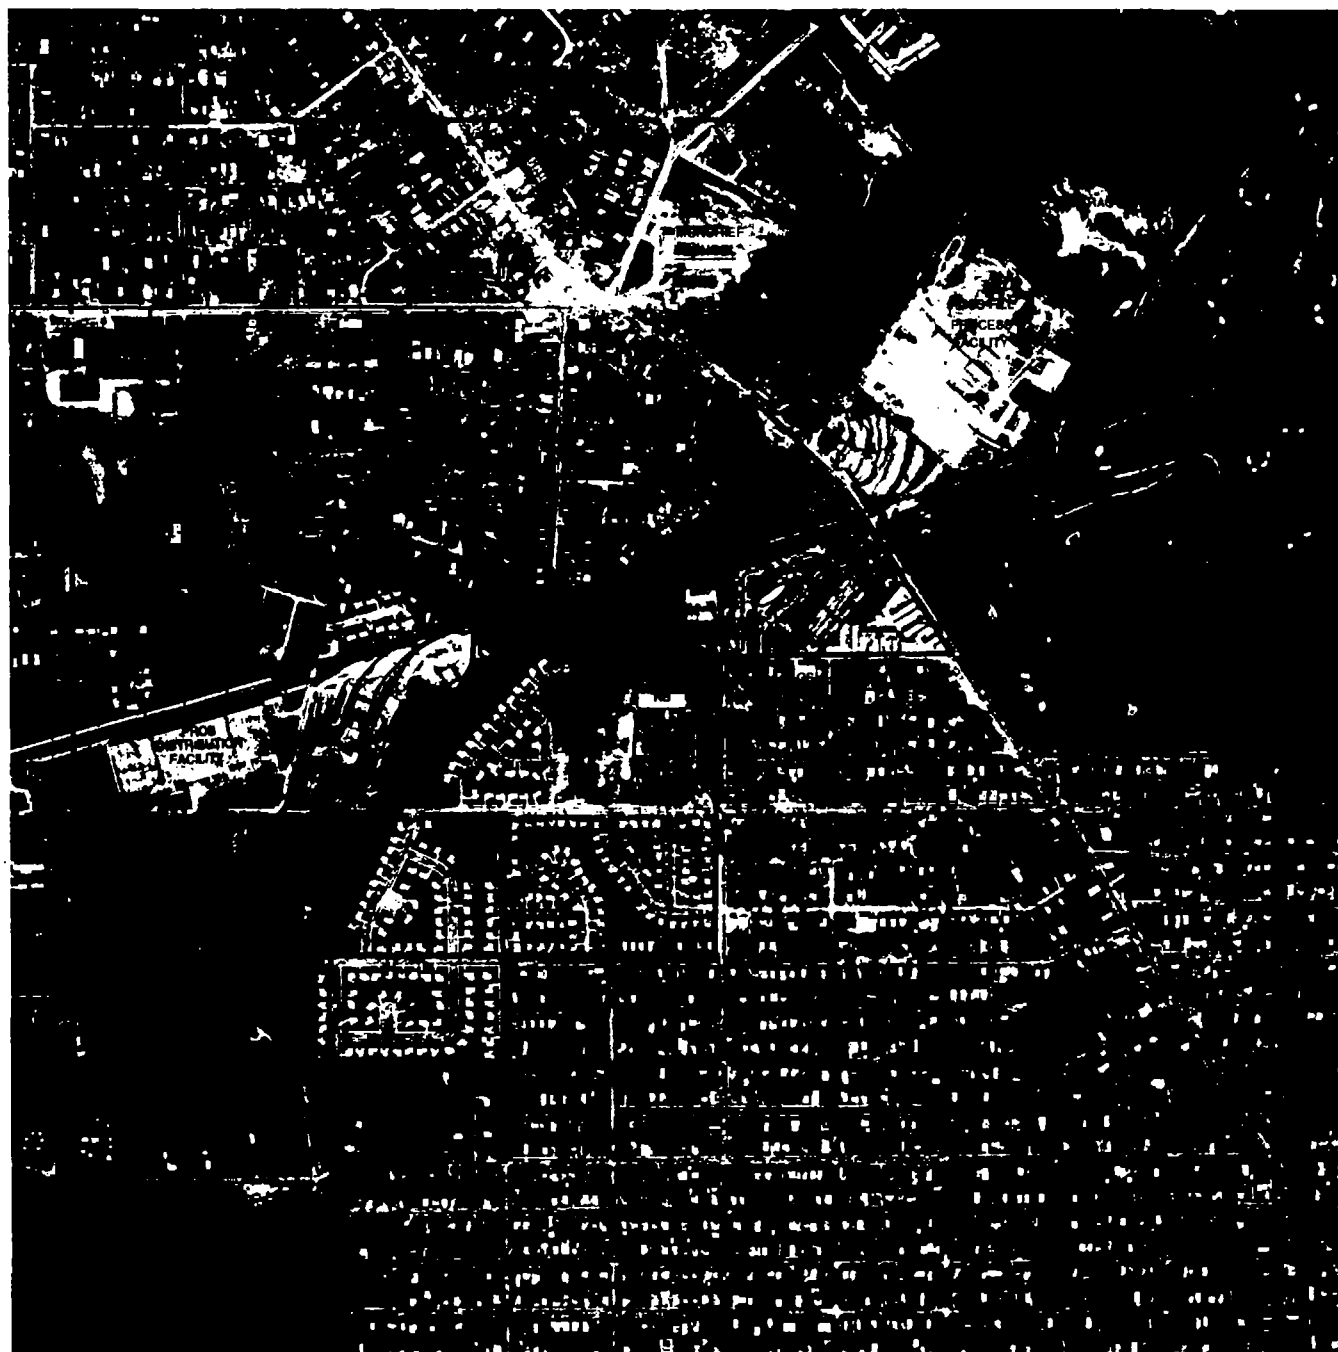
Figure 8. Brown's Dump study area, January 23, 1966. Approximate scale 1:8,675.

JANUARY 23, 1966 (FIGURE 8)

North of the railroad tracks, possible waste disposal area WDA-1 and buildings remain. Vehicles are observed in the area and as well as discarded vehicles. East of the possible waste disposal area WDA-1, there appears to be an intentional thinning of a portion of the wooded area.

South of the railroad tracks and south of the power substation, ground scar GS-3 observed in 1960 at the former location of a portion of the ash dump has revegetated. Just to the east in the apartment complex, dumping of possible municipal waste is noted just south of the railroad tracks. Near the center of the complex, ground scar GS-4 is still evident. Further east, the piles of fill (FL-3) observed in 1960 are no longer visible. A new apartment complex has been constructed in this area.

West of the power substation, due to a heavy vegetation canopy, the small pit containing standing liquid (SL-5) in 1960 is not discernible. Further west, the possible building foundation has now been developed into an earth-covered bunker (ECB). The road nearby, which was under construction in 1960, has been paved and the area is now residential. At the northeastern end of the road, the small area of light-toned material observed in 1960 is no longer visible.

At the Mary McLead Bethune Elementary School a new building (NB) has been constructed just to the north of the existing buildings. Ground scar GS-2 west of the school has expanded in size. South of 33rd Street, the residential area appears to be completed.

Off site, but within the study area to the northeast, a large ditch is visible along Moncrief Road near Moncrief Creek. Nearby, are two separate areas of fill (FL-4). The extraction area to the northeast is reduced in size

and is now partially revegetated. The southeast portion of the study area appears unchanged. In the southwest, residential areas continue to develop. However, there is still farmstead area present. Within the southwest area and south of 26th Street is a ground scar (GS-6). Just to the north, along Moncrief Creek are piles of fill (FL-5). North of 33rd Street and along the railroad tracks is a possible Grain Process Facility with six possible silos. Another new facility to the west is a Probable Distribution Facility. The northwest part of the study area appears to be unchanged.

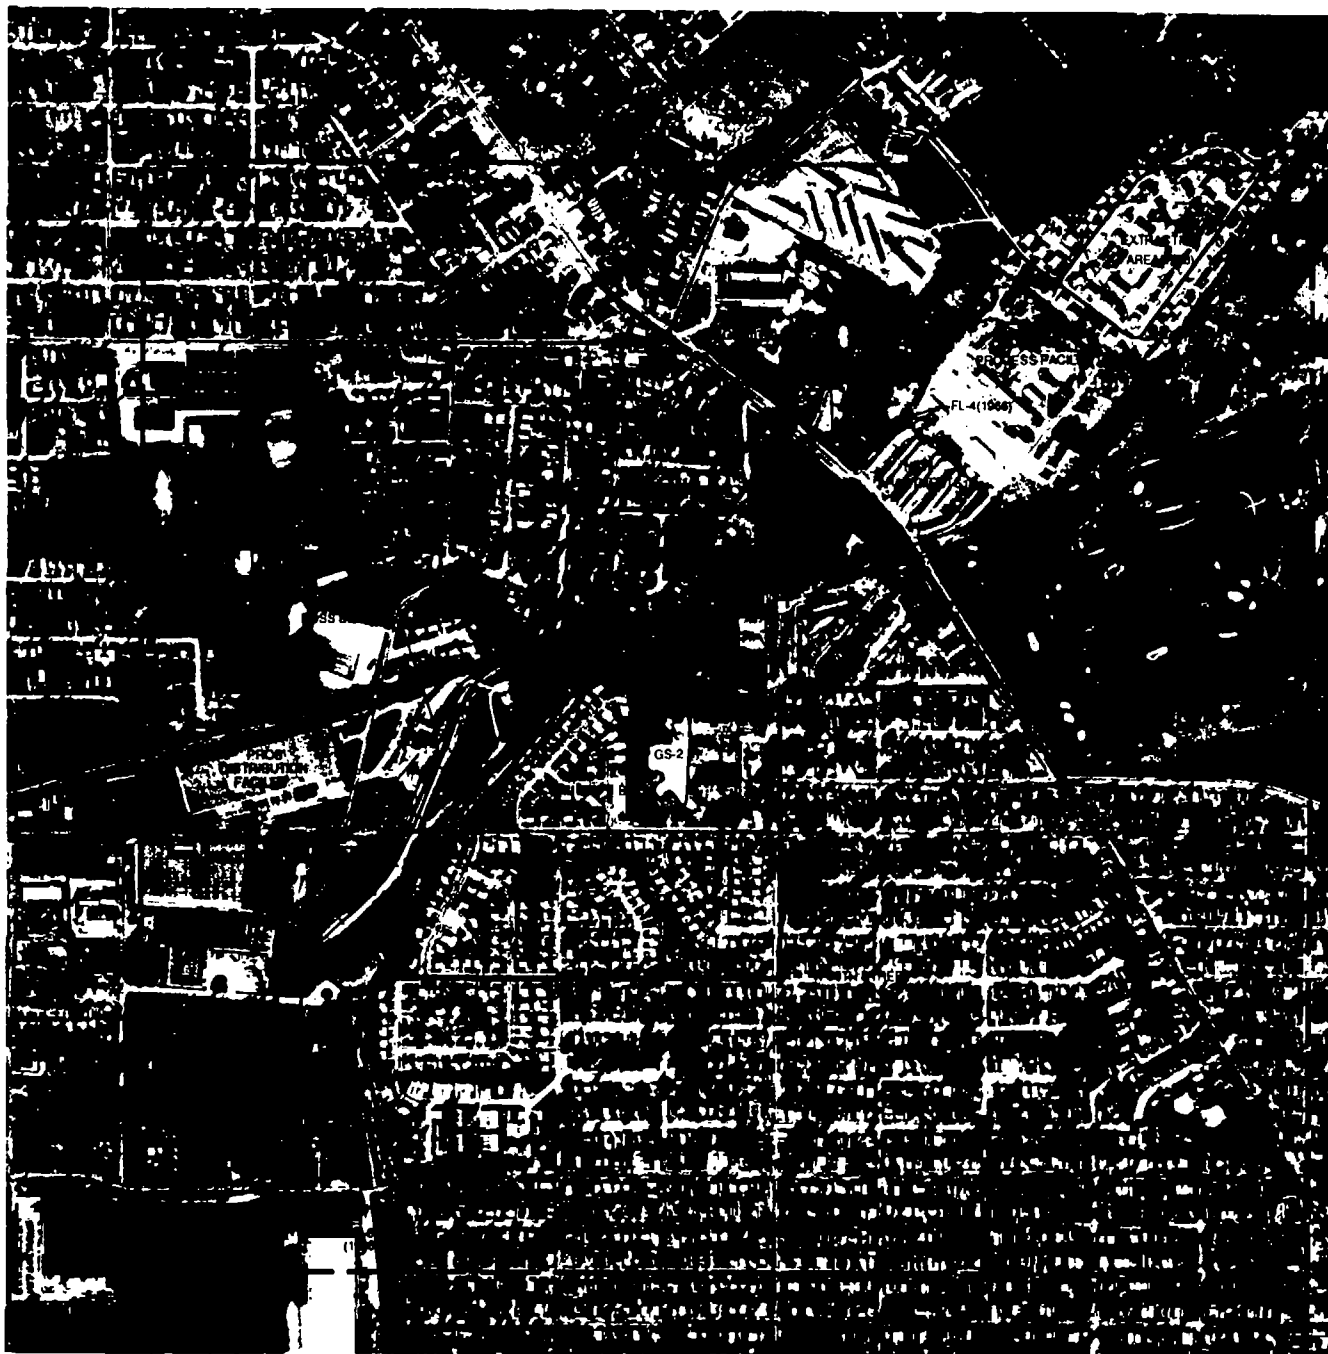
Figure 9. Brown's Dump study area, January 16, 1973. Approximate scale 1:9,000.

JANUARY 16, 1973 (FIGURE 9)

North of the railroad tracks, possible waste disposal area WDA-1 noted from 1956 to 1966 appears to have been converted into a probable junkyard. Discarded cars, and other debris are apparent and there is an increase in vegetation which may indicate a decrease in activity. East of the probable junkyard, the remaining trees in the portion of the wooded area observed in 1966 have been removed and this is now a cleared area (CA-3).

South of the railroad tracks, in the apartment complex, the dumping of possible municipal waste noted in 1966 is no longer visible. Near the center of the complex, ground scar GS-4 is still present. West of the substation, the probable earth-covered bunker remains. The area west of Mary McLead Bethune Elementary School is still ground scarred (GS-2).

Within the study area, but off the site in the northeast, the large ditch observed in 1966 along Moncrief Road near Moncrief Creek is filled. Nearby, the separate areas of fill (FL-4) observed in 1966 appear to have been removed. To the south, a new apartment complex has been constructed. The extraction area noted in 1966 has been developed into a new residential area. In the southwest part of the study area, residential areas continue to develop. However, some development of industrial facilities is apparent along with rail spurs. Within the southwest area and south of 26th Street, ground scar GS-6 observed in 1966 has revegetated. Just to the north, along Moncrief Creek, the piles of fill (FL-5) are no longer visible. The northwest portion of the study area appears unchanged.

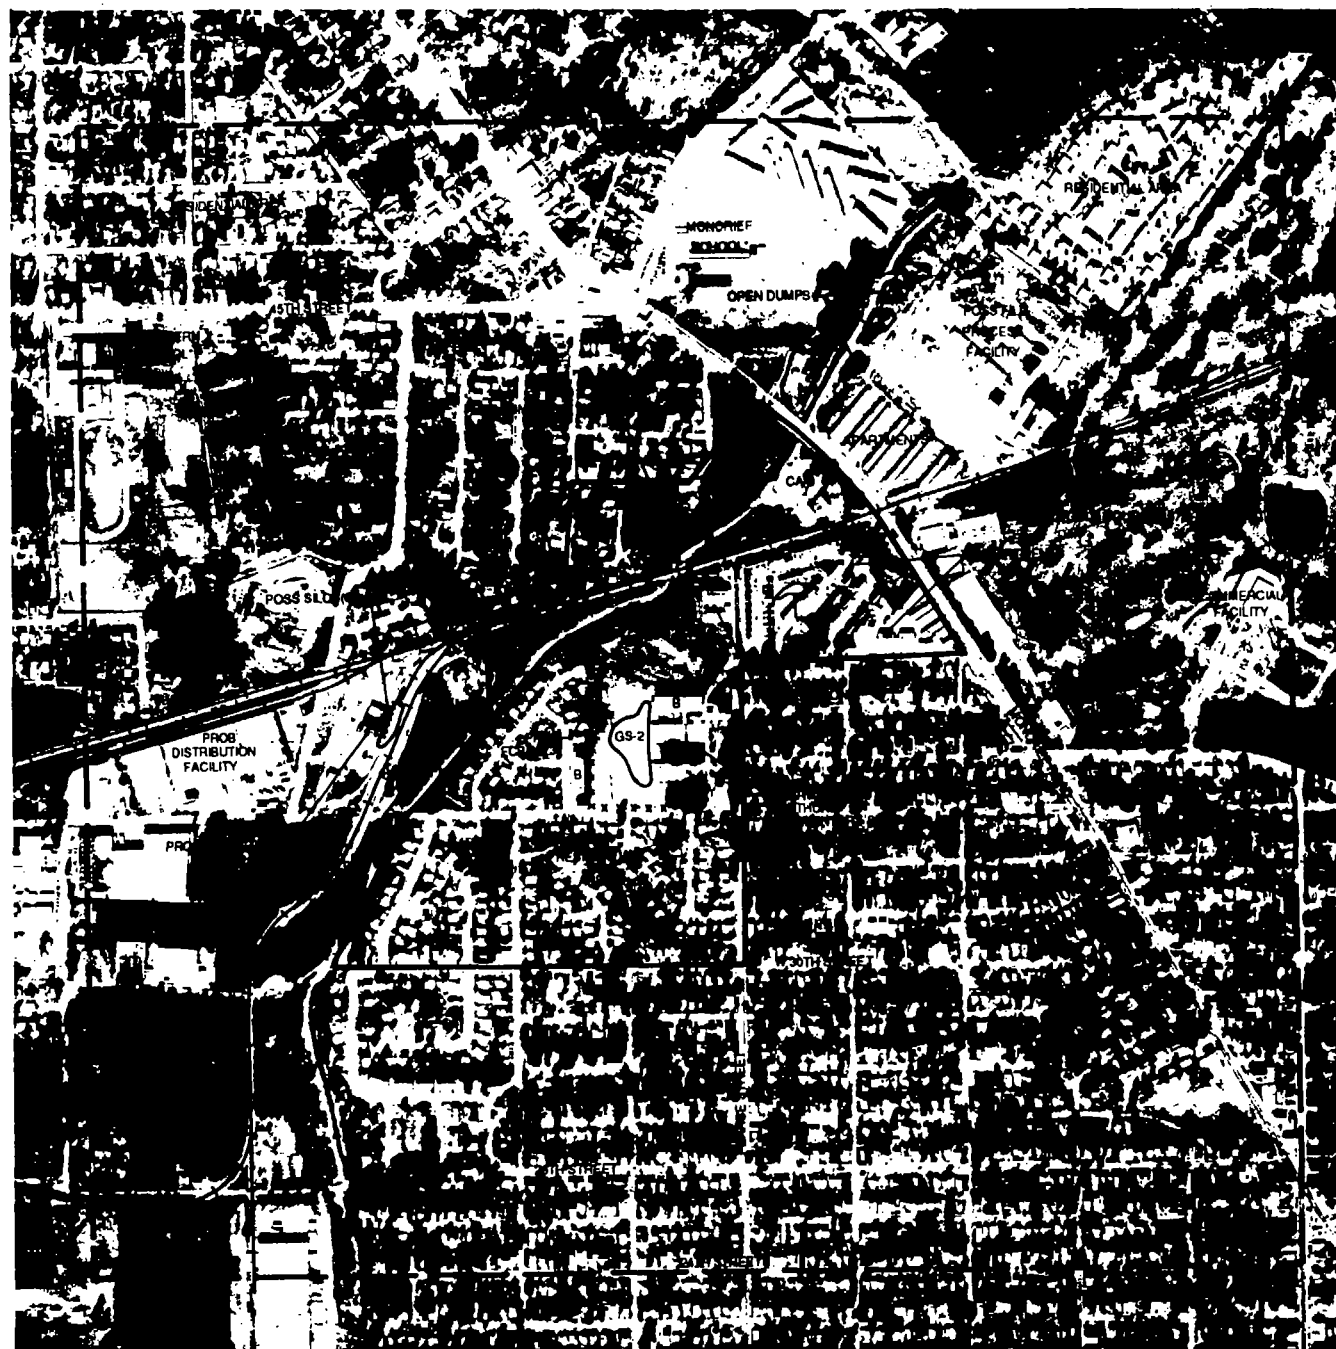
Figure 10. Brown's Dump study area, January 5, 1982. Approximate scale 1:8,675.

JANUARY 5, 1982 (FIGURE 10)

North of the railroad tracks, features observed in 1973 in the probable junkyard have been removed and the facility appears inactive. Just to the east, cleared area CA-3 has expanded in size.

South of the railroad tracks, and east of the substation near the center of the apartment complex, ground scar GS-4 remains. West of the substation, the probable earth-covered bunker is covered by vegetation. Ground scar GS-2 west of Mary McLead Bethune Elementary School remains unchanged.

Off site, but within the study area, in the northeast the possible fill process facility remains. Open dumping is visible along Moncrief Creek and near the possible fill process facility. The golf course, last observed in 1973, is no longer active. A commercial facility has been developed in the area. No further environmentally significant change in this area is observed since the previous analysis year.

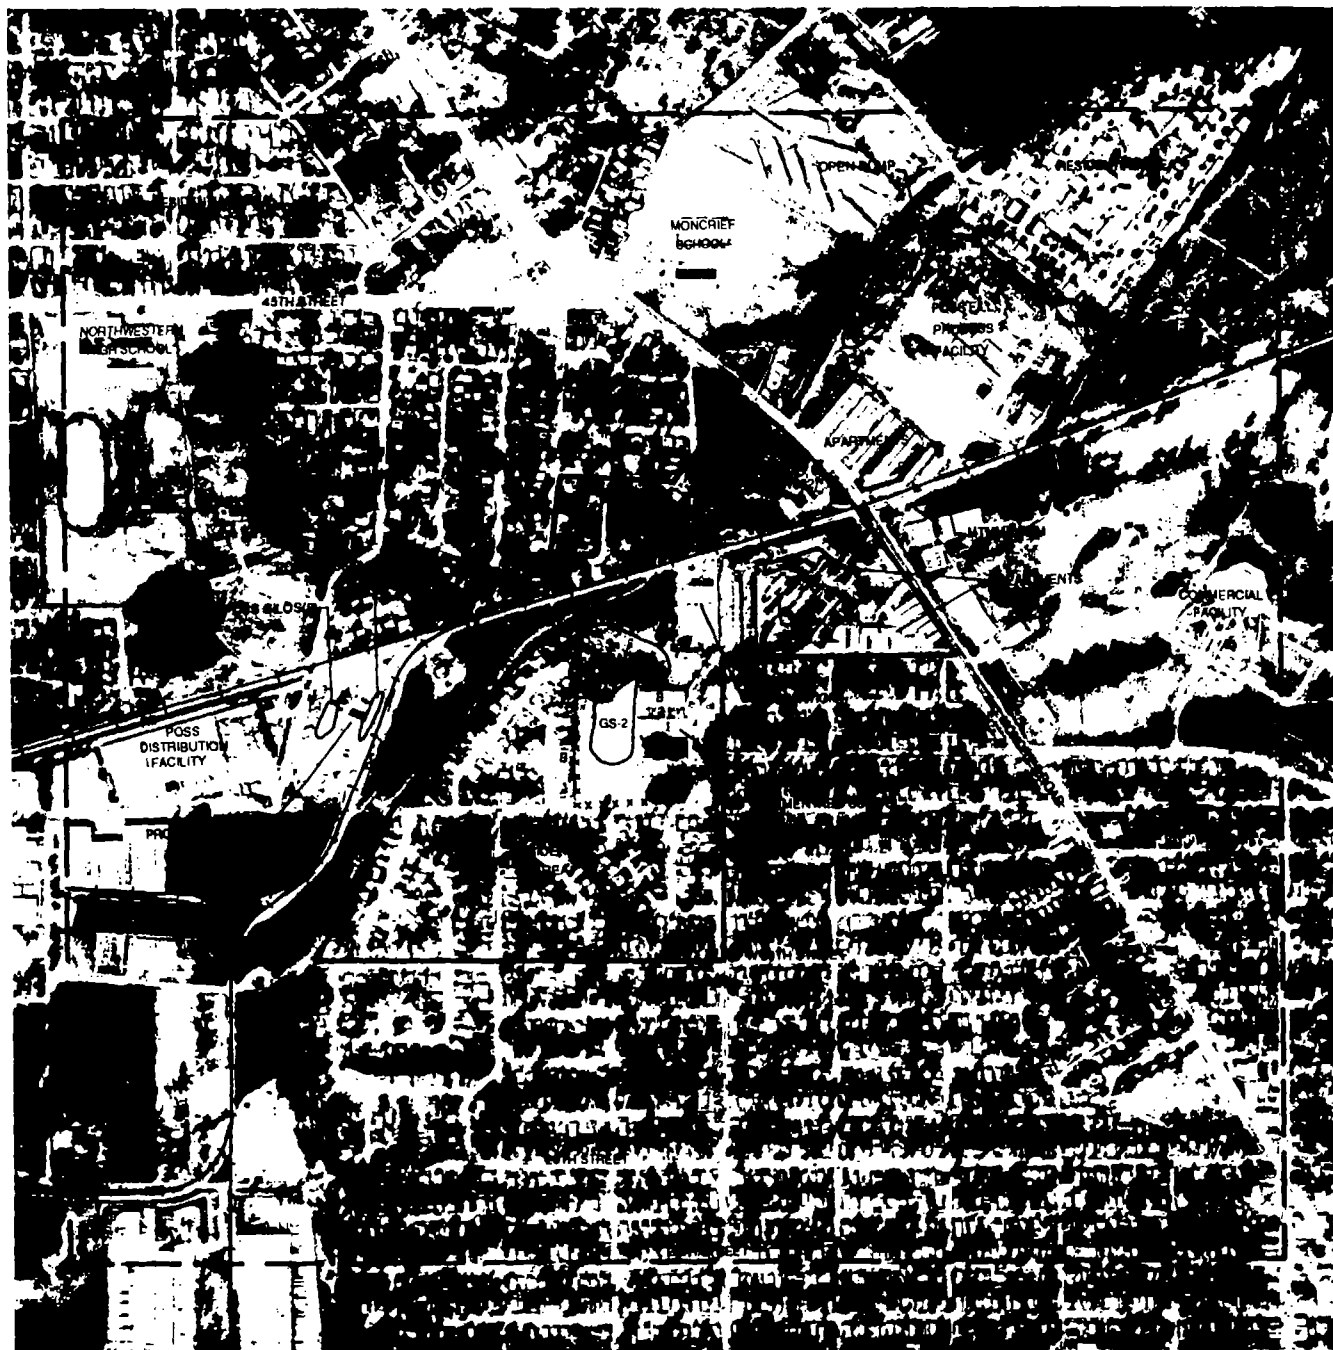
Figure 11. Brown's Dump study area, January 22, 1988. Approximate scale 1:8,675.

JANUARY 22, 1988 (FIGURE 11)

North of the railroad tracks, cleared area CA-3 observed in 1982 is now overgrown.

South of the railroad tracks, and east of the substation near the center of the apartment complex, ground scar GS-4 noted in 1982 is overgrown. No change is noted in ground scar GS-2 west of Mary McLead Bethune Elementary School. Just north of ground scar GS-2 is a large graded area along the east side of the berm.

Offsite, but within the study area to the northeast, the possible fill process facility remains. The open dumping along Moncrief Creek and near the possible fill process facility appears to have expanded; light and dark-toned materials and debris are observed within the open dump. The commercial facility is still present on the eastern side of the study area. Just south of the railroad tracks, and east of Moncrief Road are several mounds of medium-toned (MT) and dark-toned material. West of the site, the possible grain process facility has constructed 11 new possible silos.

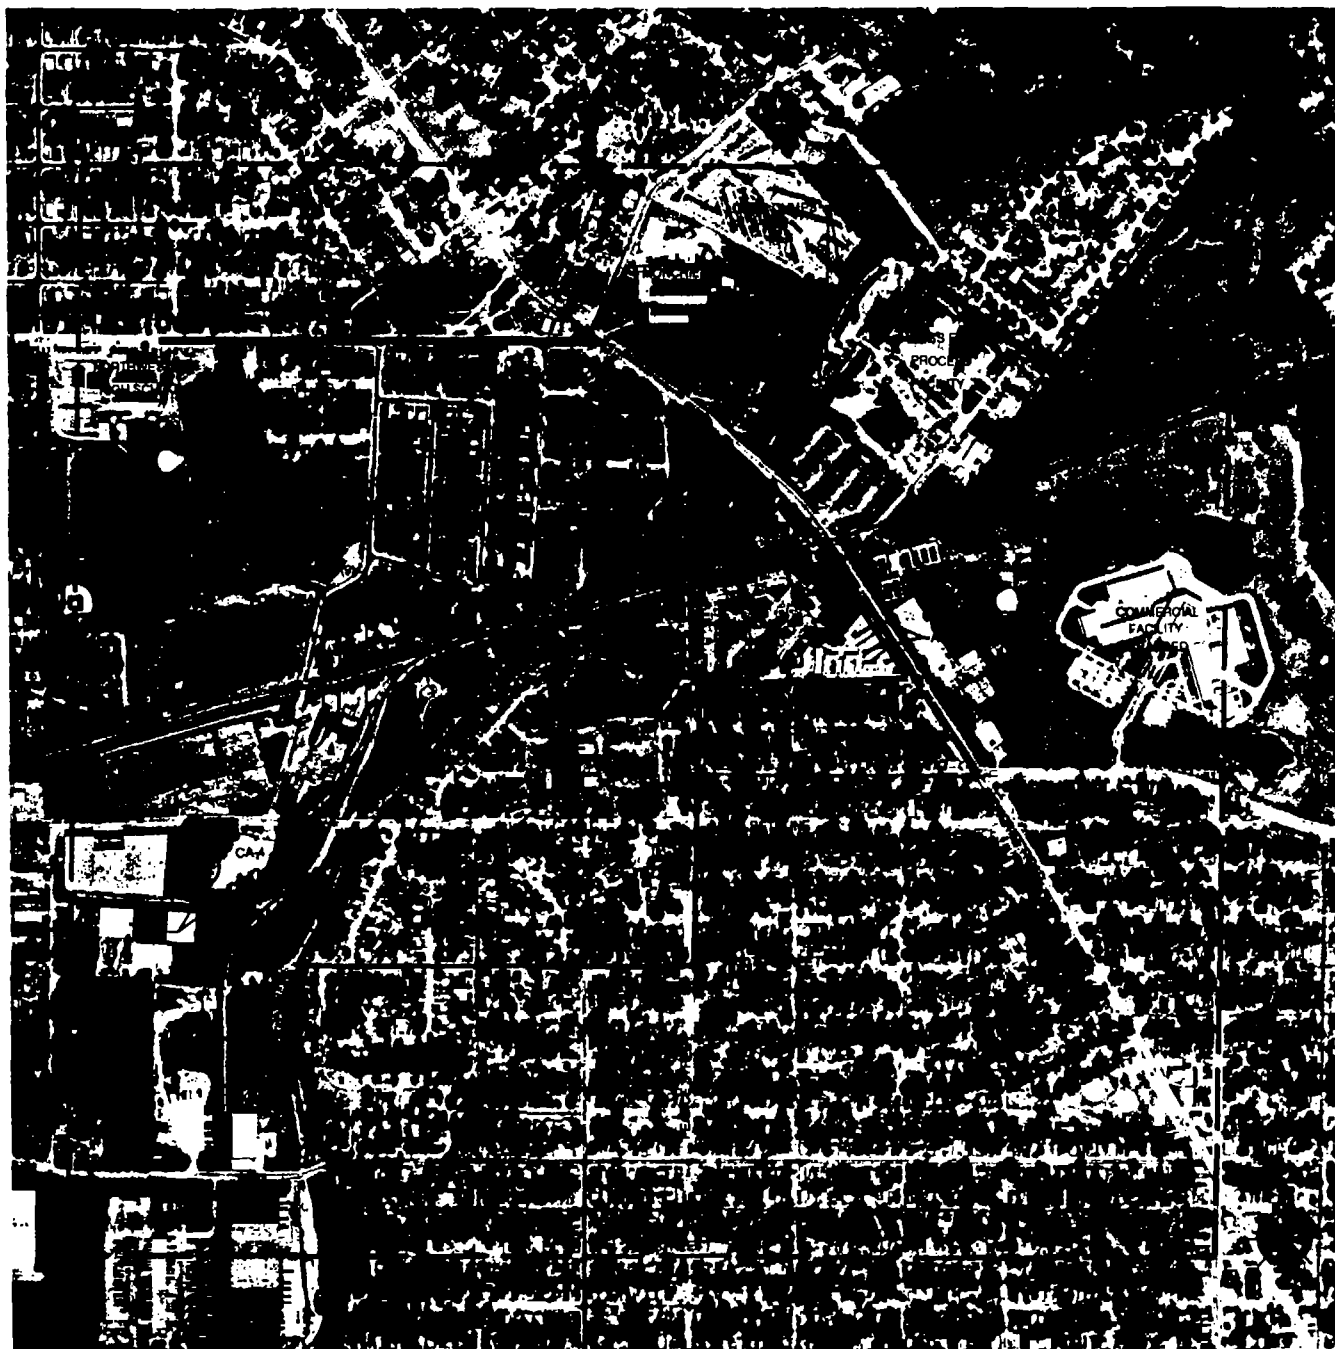
Figure 12. Brown's Dump study area, November 10, 1997. Approximate scale 1:9,000.

NOVEMBER 10, 1997 (FIGURE 12)

The greatest extent of the ash dump (for any year examined in this analysis) and any possible waste disposal area (WDA) is shown on the 1997 photograph overlay (Figure 12).

No environmentally significant change has occurred since the previous analysis year.

No environmentally significant change has occurred since the previous analysis year. In the area west of Mary McLead Bethune Elementary School, ground scar GS-2 is smaller in size compared to 1988 and is divided into two separate areas.

Offsite, but within the study area to the northeast, the possible fill process facility remains. The open dump along Moncrief Creek and near the possible fill process facility has visible light and dark-toned materials present and debris is still observed within the open dump. Bulldozers appear to have moved materials on the open dump and a face is noted on the dump's northwest side. The southern end of the open dump area is outside the actively worked area. South of the railroad tracks and east of Moncrief Road, the mound of medium- and dark-toned material observed in 1988 has been removed. To the east, the commercial facility has expanded since 1988. In the southwest, south of the probable distribution facility, is a cleared area (CA-4) and on either side are several piles of fill (FL-6); the remaining area is residential, and industrial. In the northwest, a large retention pond is present north of the railroad tracks. Drainage appears to flow from the surrounding residential area into this retention pond.
